Gilles Consulting

EVALUATION OF TREES AT THE UPS PARKING LOT EXPANSION At the Southeast Corner of the Intersection of NE Union Hill Road & 185th Avenue NE Redmond, WA 98052

January 30, 2019

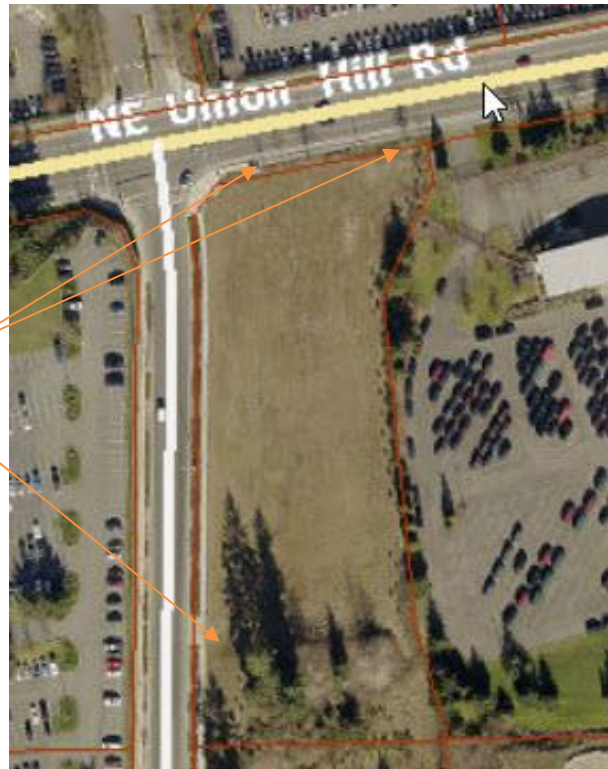
Photo # 1: A screen shot from the King County Assessor's website showing the property on a 2015 aerial photo with the property lines approximately super-imposed. Note the five trees along NE Union Hill Road and the cluster of 25 trees near the south property line.

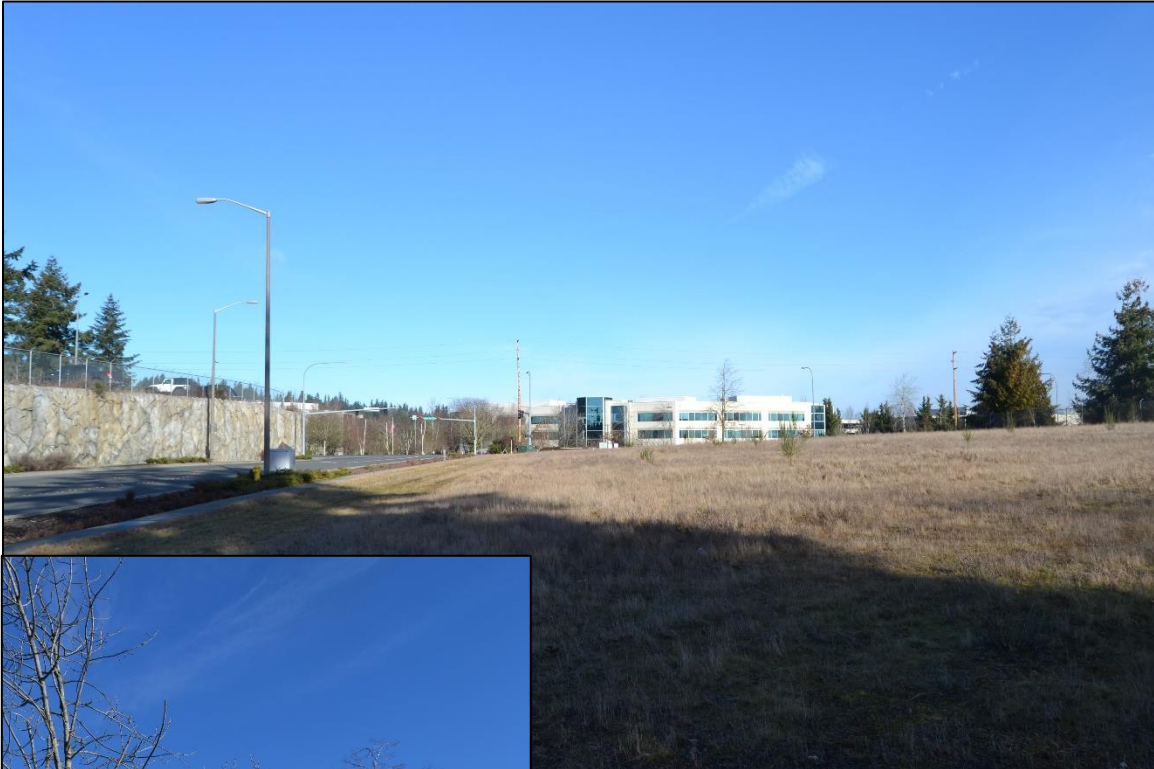
Photo # 2: Looking north from near the base of the mound at the gently sloping majority of the lot.

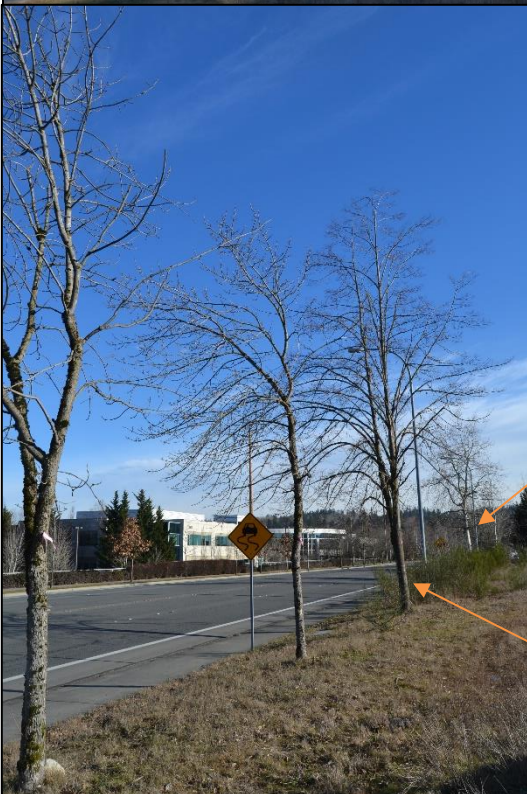
Photo # 3: Looking east along the north property line at the row of five trees along NE Union Hill Road. Two of the five trees are *Significant*. They are

Tree # 131, and

.Tree # 485

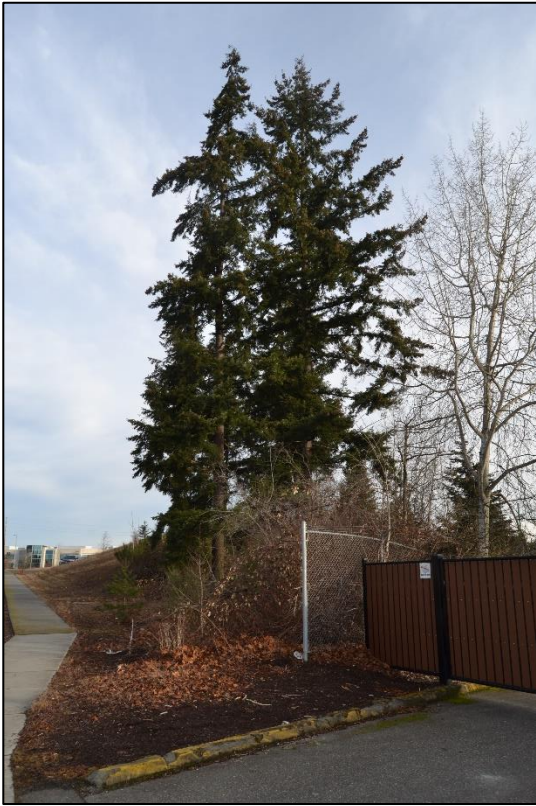
Photo # 4: Looking NE from the 185th Avenue NE sidewalk at the trees on the south portion of the property. The end of the chain link fence is the approximate property corner.

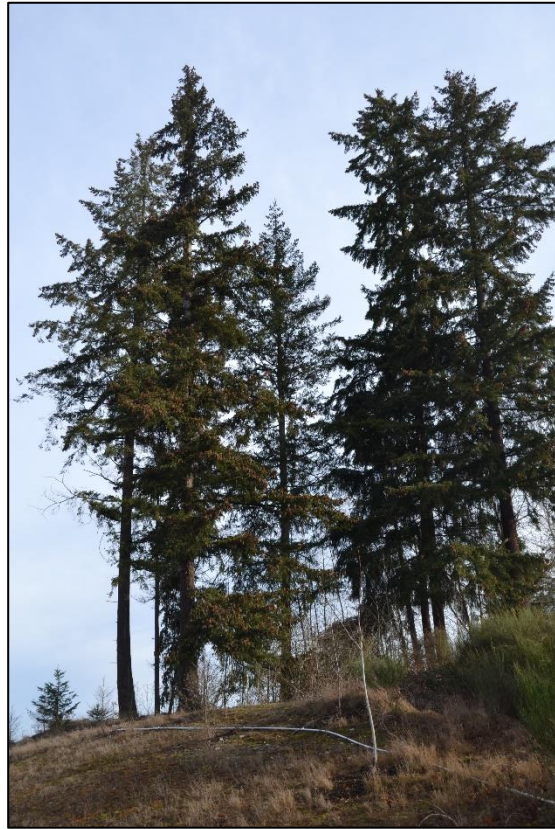
Photo # 5: Looking at trees 467 – 479 on the mound.

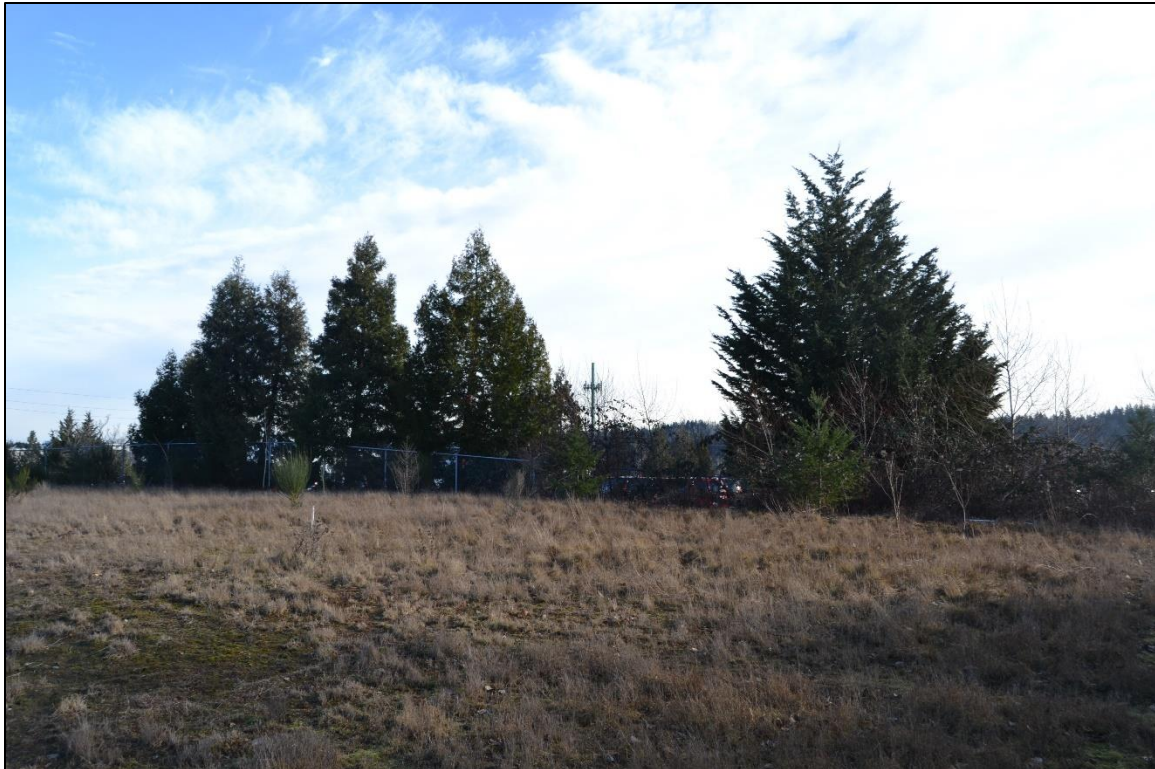
Photo # 6: Looking at landscape trees east of the east property line. Just behind the fence one can just make out several vans parked in the lot. These trees can all be adequately protected with *Tree Protection Fencing* placed five feet west of the east property line.
